# 2022 Data Report for

# Round Lake, Mecosta County

Site ID: 540073

# Round Lake, Mecosta County 2022 CLMP Results

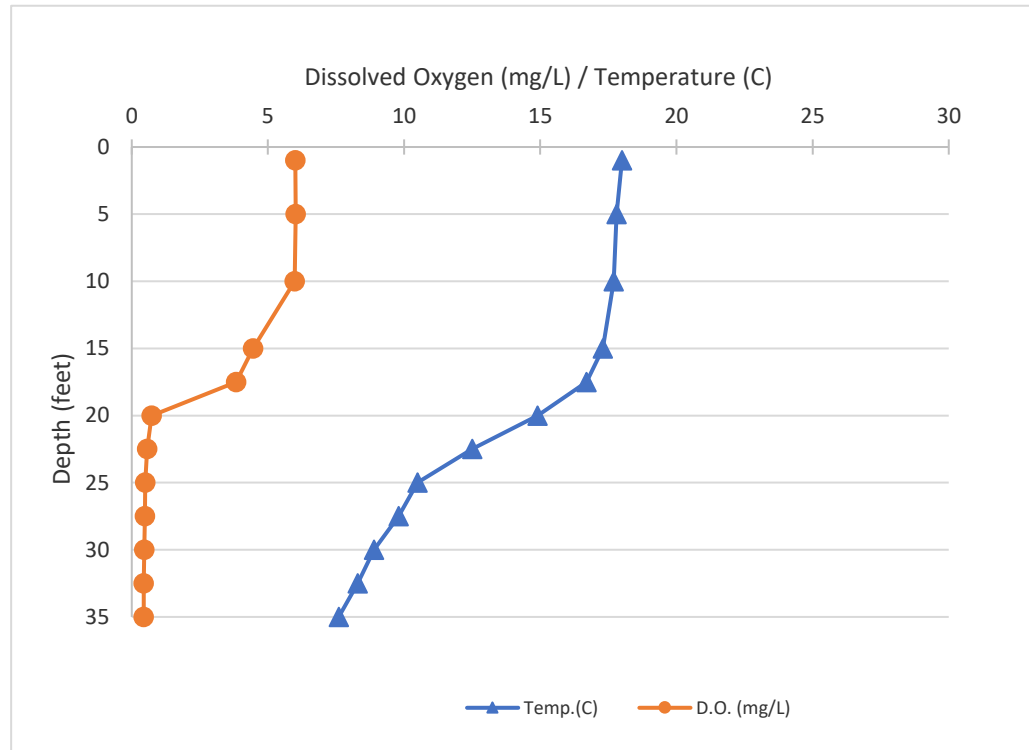
Name: Round Lake  
County: Mecosta  
Site ID: 540073  
Date: 9/14/2006

Depth (ft)	Temp.(C)	D.O. (mg/L)
1	18	6
5	17.8	6.02
10	17.7	5.98
15	17.3	4.46
17.5	16.7	3.83
20	14.9	0.73
22.5	12.5	0.56
25	10.5	0.5
27.5	9.8	0.48
30	8.9	0.46
32.5	8.3	0.44
35	7.6	0.44
