2022 Data Report for

Blue Lake, Mecosta County

Site ID: 540092

Blue Lake, Mecosta County 2022 CLMP Results

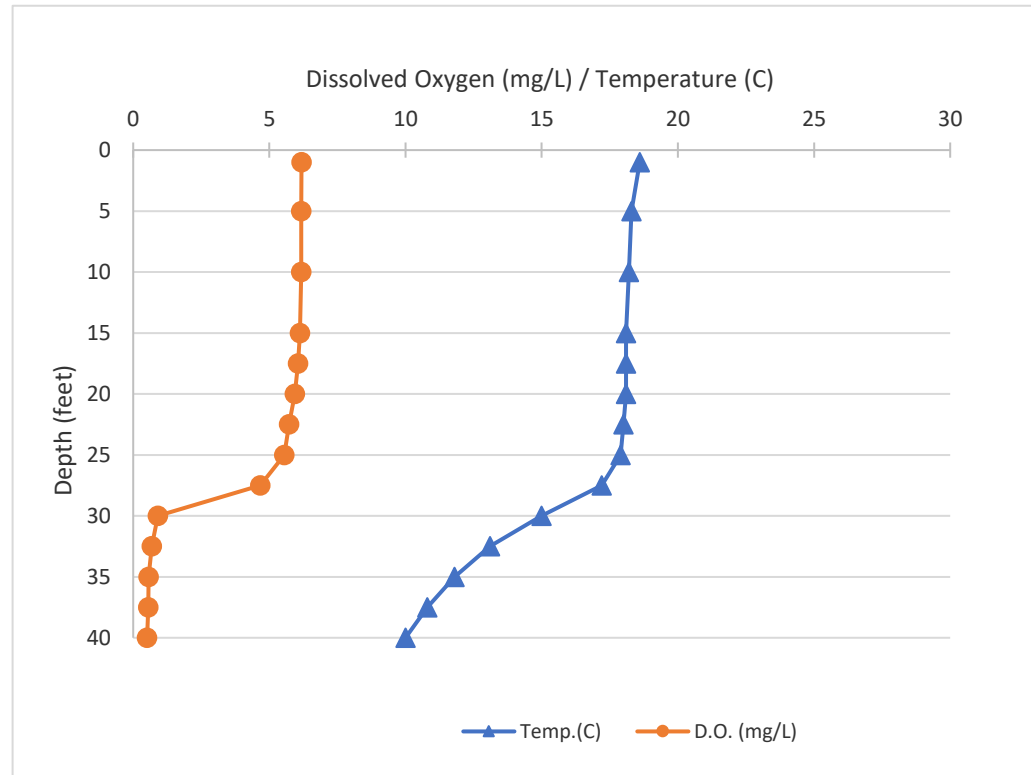
9/14/2006

Dissolved Oxygen and Temperature Profile

Depth (ft)	Temp.(C)	D.O. (mg/L)
1	18.6	6.18
5	18.3	6.17
10	18.2	6.17
15	18.1	6.12
17.5	18.1	6.05
20	18.1	5.93
22.5	18	5.72
25	17.9	5.55
27.5	17.2	4.67
30	15	0.91
32.5	13.1	0.68
35	11.8	0.57
37.5	10.8	0.55
40	10	0.51
