2022 Data Report for

Lake Mecosta, Mecosta County

Site ID: 540057

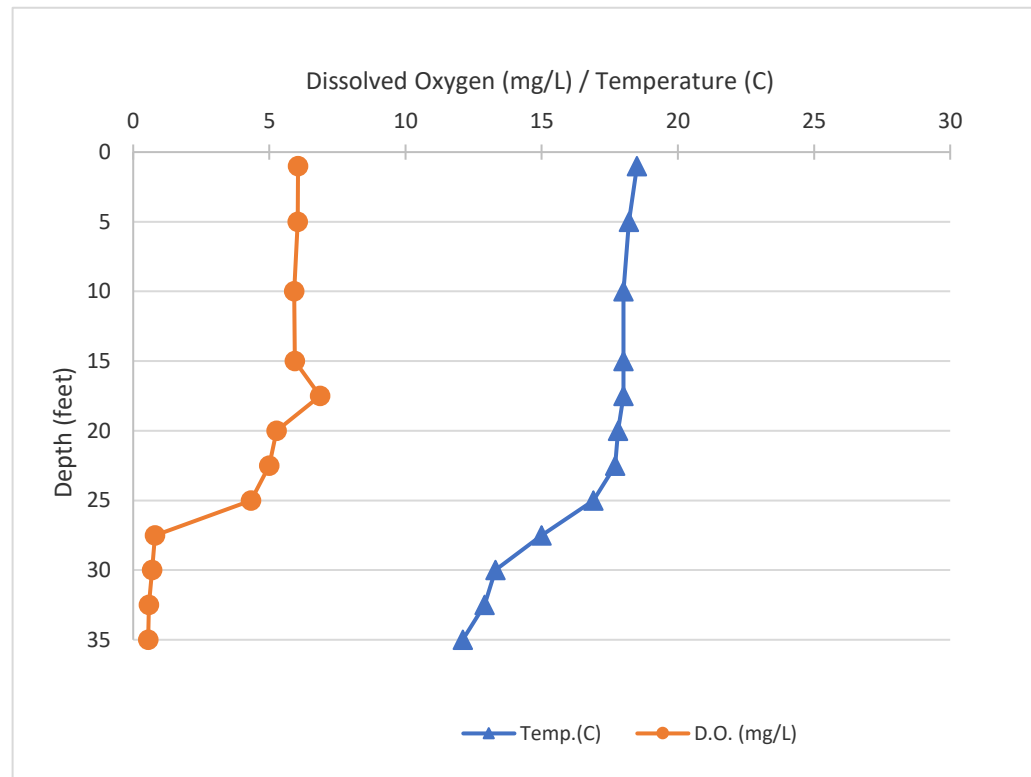
Name: Lake Mecosta
County: Mecosta
Site ID: 540057
Date: 9/14/2006

Depth (ft)	Temp.(C)	D.O. (mg/L)
1	18.5	6.05
5	18.2	6.04
10	18	5.91
15	18	5.94
17.5	18	6.86
20	17.8	5.27
22.5	17.7	4.99
25	16.9	4.32
27.5	15	0.8
30	13.3	0.69
32.5	12.9	0.58
35	12.1	0.55
